LC Building Management Group
Lake Star Hotel - Seattle
Lake Star Hotel

Prior Inspection No : 10104 April 4, 1994
Current Inspection No : 10105 May 5, 1995

I/C Electrical Problem Documentation

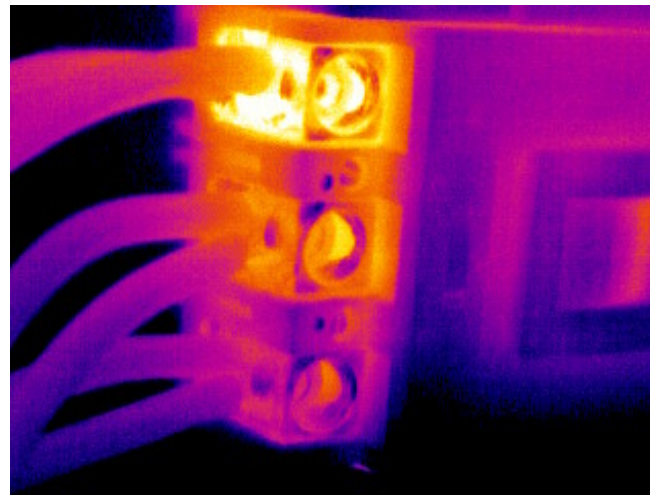
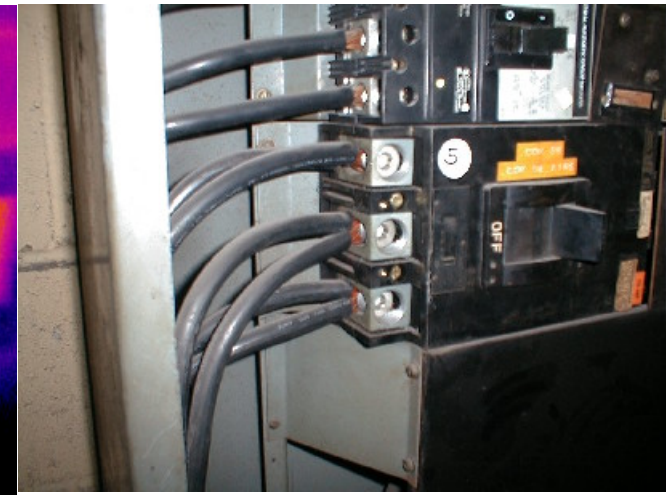
Main Building
1 Floor
Main Elect Vault
MCC 1
Sup Fan 1

Repair Priority: **2-Serious**

Component Temperature On A Phase: **185 F**

C Phase Reference Temperature: **130 F**

Temperature Rise Above Reference: **55 F**

A Phase line side wire lug connection on circuit breaker - 100 amp

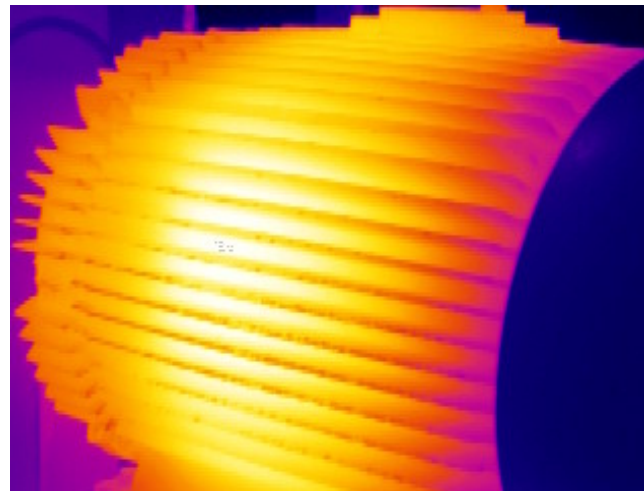
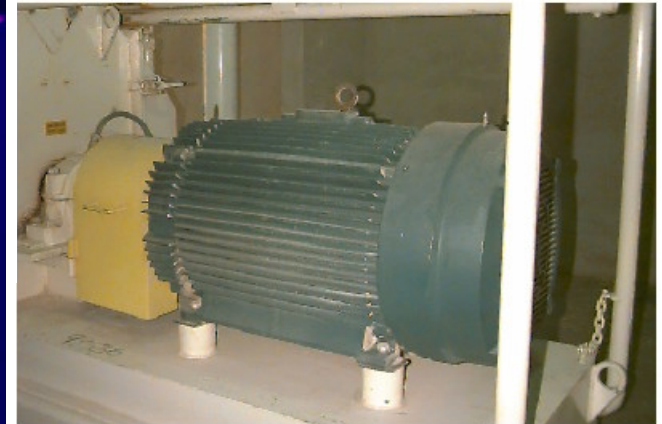
Equipment ID: w5543
 Main Building
 1 Floor
 Mech Room
 Main Chill Water Pump Motor

Is Chronic: **No**
 Operation Priority: **Essential to operation**
 Repair Priority: **2-Serious**
 Component Temperature: **210 F**
Reference Temperature: 135 F
Temperature Rise Above Reference: 75 F
 ANSI/EEE/NEMA Max Allowable Temp @ 100% Load: **F**

abnormal heating on Motor Bearing

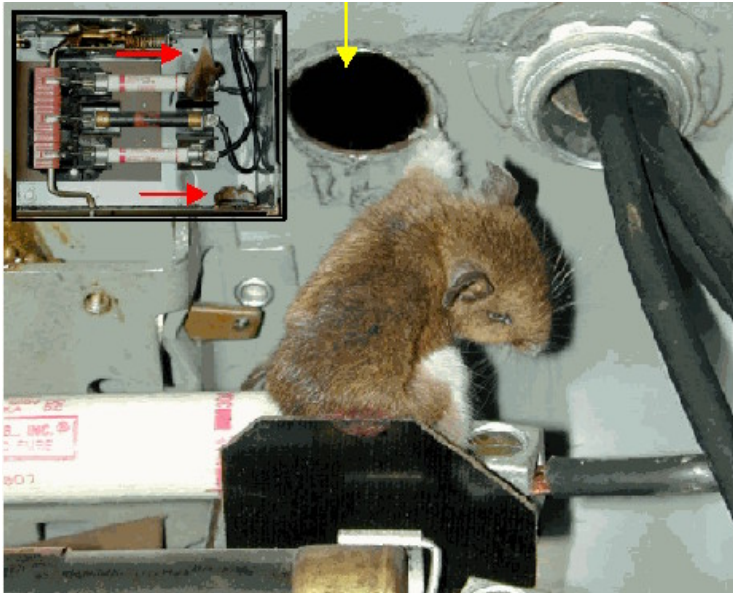
Hazard Issue: Mouse shorting out circuit

Observations: Animals, Mouse shorting out circuit - having a bad day on A phase

Hazard Classification: Potential Fire Hazard

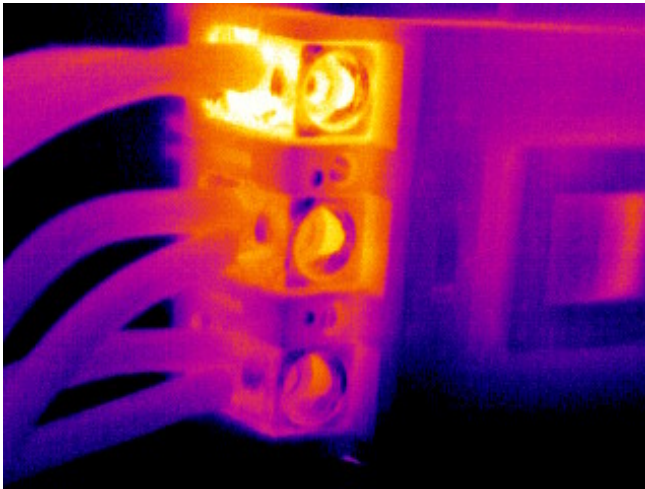
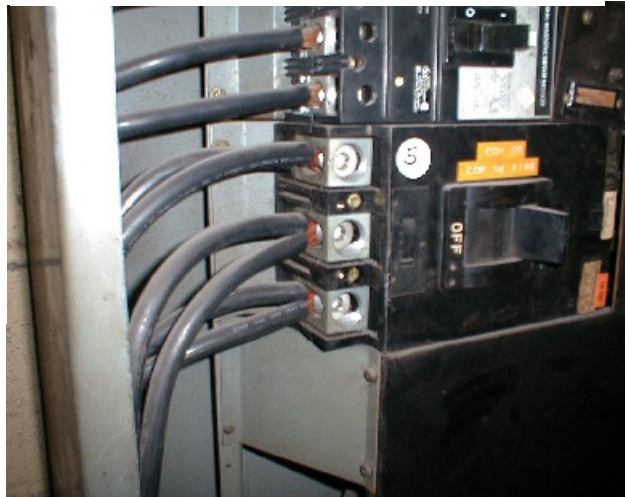
Location/Equipment Information	
Asset ID:	6501-0010-0002
Main Building	1 Floor
	Main Elect Vault
	MCC 1
	Sup Fan 1
A Phase line side wire lug connection on circuit breaker - 100 amp

Thermal Information	
Repair Priority:	2-Serious
Component Temperature On A Phase:	185 F
C Phase Reference Temperature:	130 F
Temperature Rise Above Reference:	55 F

Dissassemble clean, reassemble tighten.

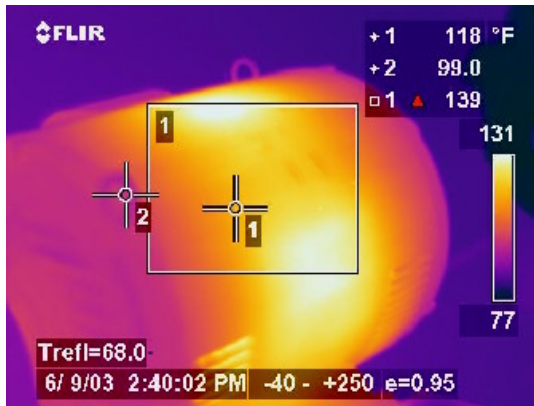
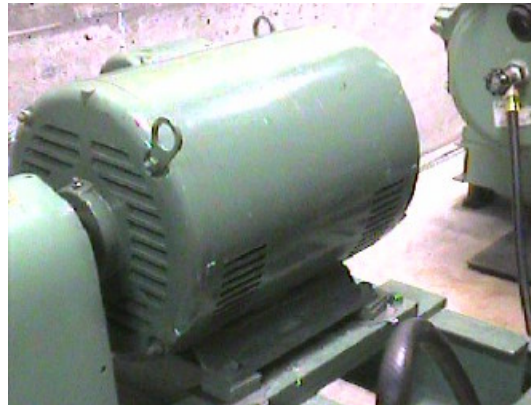
Main Building \ 1 Floor \ Mech Room \ Main Chill Water Pump Motor

Inspection No	Date Inspected	Test Status	Measured Temp	Threshold Temp	Ambient Temp	Status Note	Customer Notes
10100	1/1/1991	TESTED	112 F	145 F	85 F	Motor was tested at full running load after it had been running for 3 hours.	Motor was at full running load
10102	2/2/1992	TESTED	120 F	145 F	80 F		The motor was running for 1 hour
10103	3/3/1993	TESTED	122 F	145 F	85 F		motor was running for 2 hours
10105	5/5/1995	TESTED	160 F	145 F	90 F	Test was done after 3 hours	The motor is over its Alarm Threshold temp by 15 deg.
