**INFRARED
PREDICTIVE
SURVEYS
INCORPORATED**

Subject: IR/Nuclear/Capacitance Roof Analysis Report

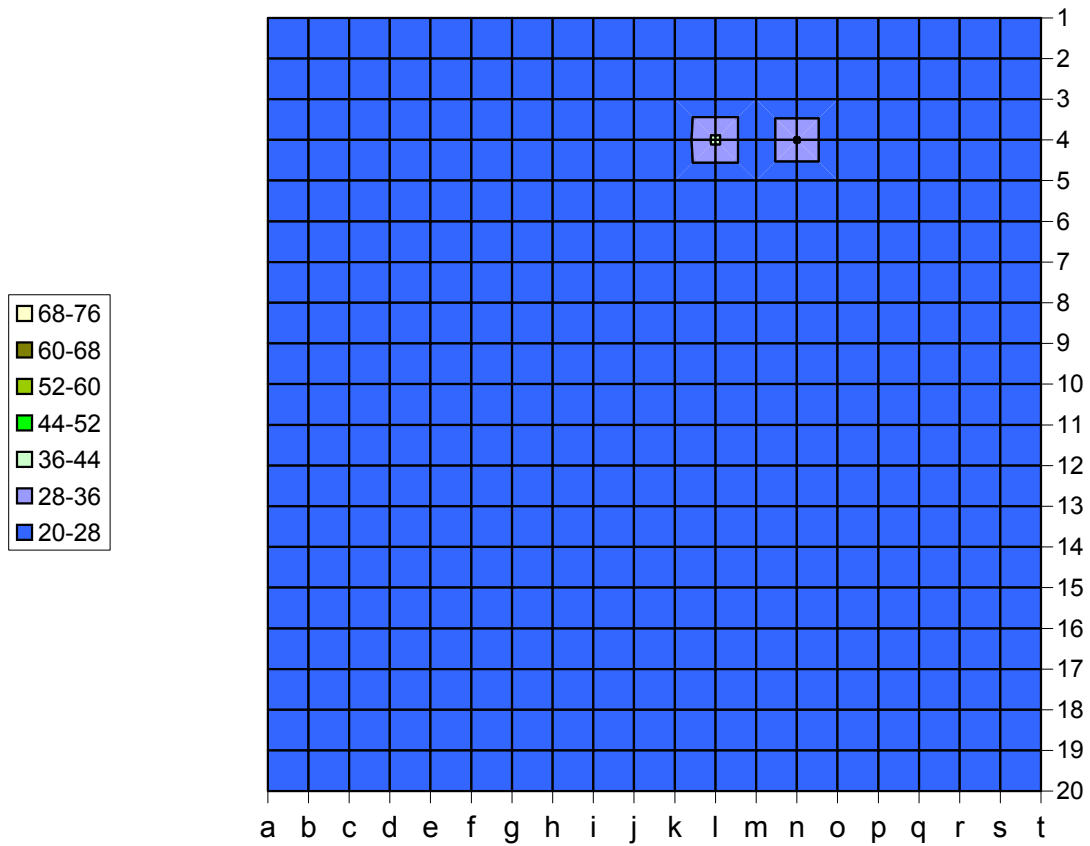
Roof Moisture Plot

Testing intervals were 7.5 seconds at each grid point location. The highest readings were located in the NE corner, over and adjacent to Unit 325.

A baseline core sample was taken on an area suspected to be either damp or dry. (The relative meter reading was "10"). The core sample was dry: felts, insulation and deck.

A second core sample was taken in the highest readings area, over unit 325. The insulation and the cementitious gypsum deck were very wet.

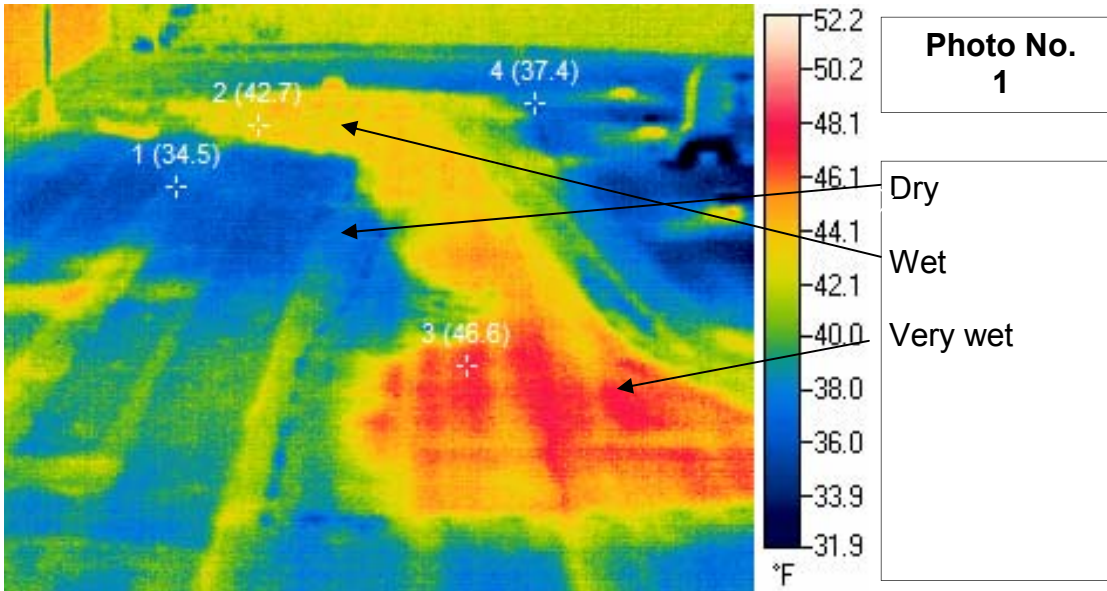
The area over and adjacent to unit 325 appears to be very wet, including the gypsum deck below. Water is in and below the roof system and it will *not* dry out.

Area 1. Over Unit 325. NE corner.

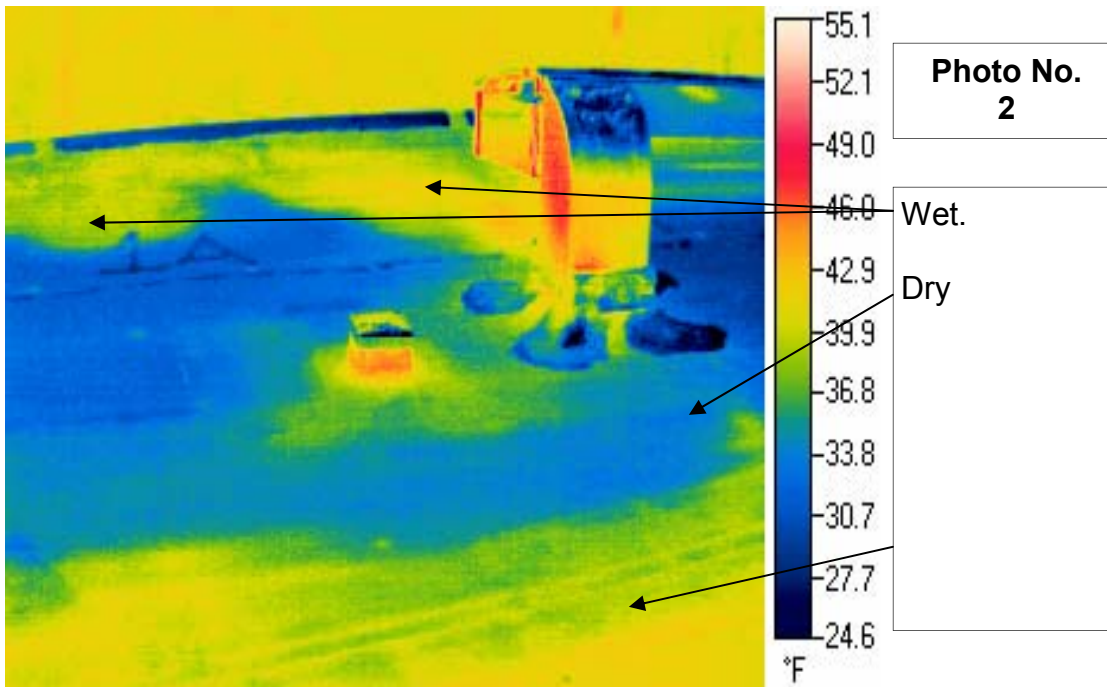
Area 1A. Over unit 325 and adjacent unit. At east elevation, near NE corner.

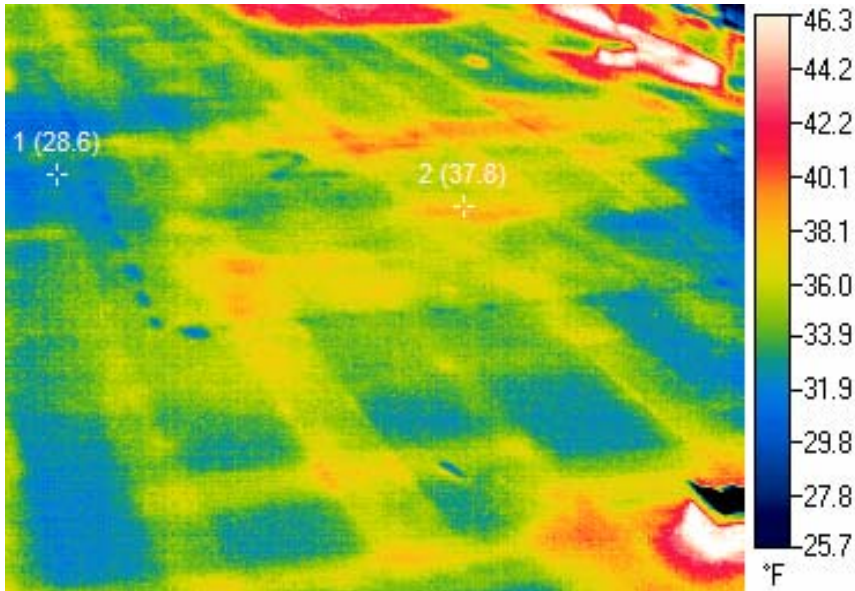
Photo No.
3

Wet areas may extend beyond paint lines.

“Hatch” patterns appear to be just more thermal mass due to strip patches.

Area 2. This is along east elevation, south of Area 1.

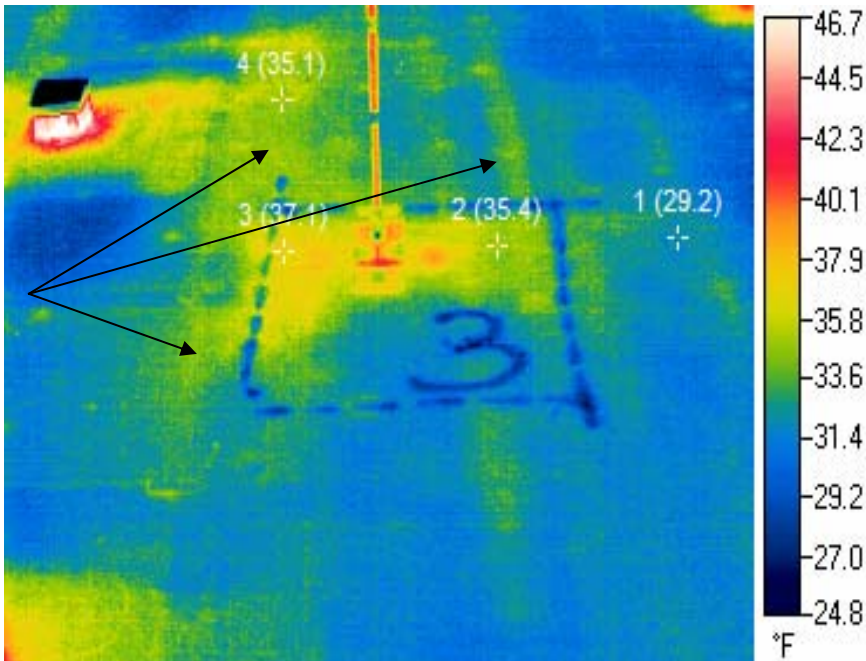
Photo No.
4

It appears the wet area extends beyond the painted line.

Area 3

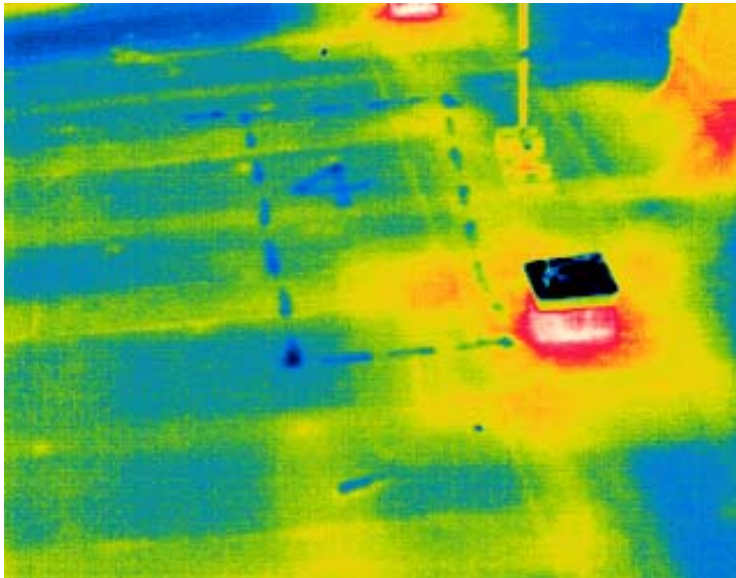
Photo No.
5

Moisture patterns extend past the paint lines.

Area 4. Center of roof.

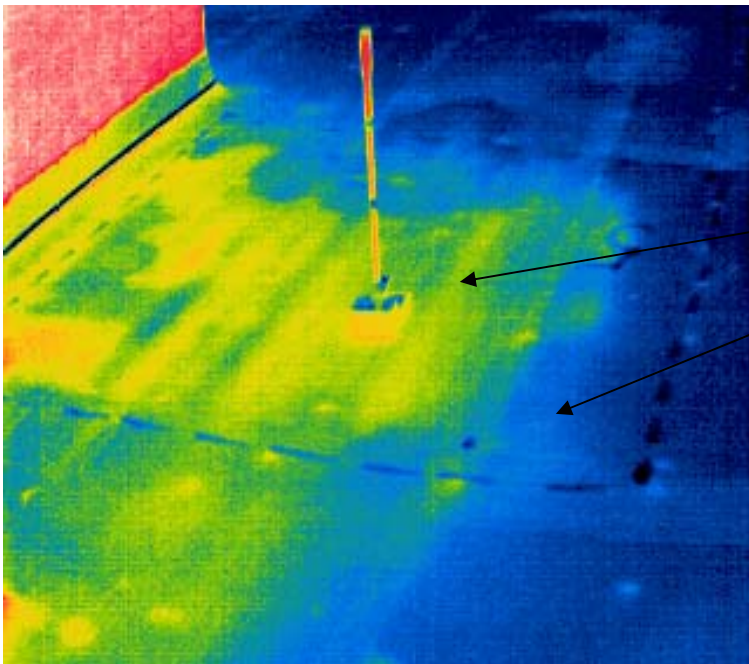
Photo No.
6

Wet

dry

Area 5. This is on the east side of the small roof towards the south elevation.
