LC Building Management Group
Lake Star Hotel - Seattle
Lake Star Hotel

Prior Inspection No : 10104 April 4, 1994
Current Inspection No : 10105 May 5, 1995

I/C Electrical Problem Documentation

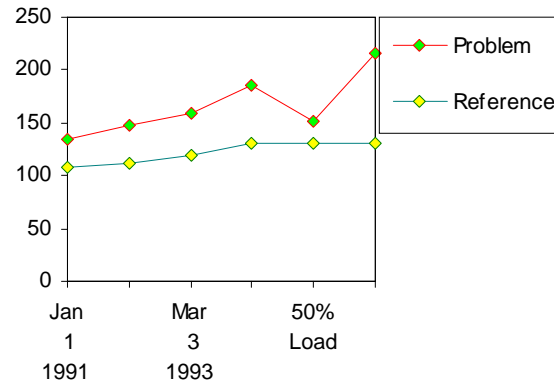
Current Prob No: I/C Electrical/2

May 5 1995 : 55F@80% vs 21F@50% / -72% Chg in 1585 Days
Mar 3 1993 : 40F@34% vs 87F@50% / 16% Chg in 792 Days
Feb 2 1992 : 37F@30% vs 103F@50% / 37% Chg in 397 Days
Jan 1 1991 : 27F @30% vs 75F@50%

Is Chronic: **Yes**

Repair Priority: **2-Serious**

Component Temperature On A Phase: **185 F**

C Phase Reference Temperature: **130 F**

Temperature Rise Above Reference: **55 F**

Main Building
1 Floor
Main Elect Vault
MCC 1
Sup Fan 1

A Phase line side wire lug connection on circuit breaker - 100 amp

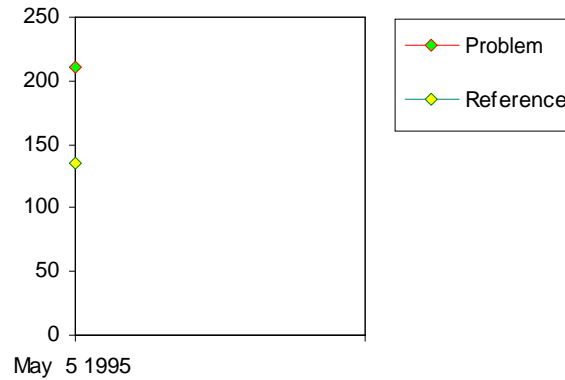
Current Prob No: Mechanical/1

Ambient: **72 F** Enviroment: **Indoors** Wind **0**
 Adjusted Temperature Rise: **75**
 Est Melting Temp of Component Material:

Component: **400hp Motors**
 Fault Type: **Mechanical**
 Manufacturer:
 Catalog No:
 Model No:
 Oil Type:
 Circuit Voltage: **120 Volts**
 Bearing Type:
Component Rated Load: 100
 Horse Power (HP):
 RPM's:

May 5 1995 : 75F @10%

Is Chronic: **No**
 Operation Priority: **Essential to operation**
 Repair Priority: **2-Serious**
 Component Temperature: **210 F**
Reference Temperature: 135 F
Temperature Rise Above Reference: 75 F
 ANSI/EEE/NEMA Max Allowable Temp @ 100% Load: **F**

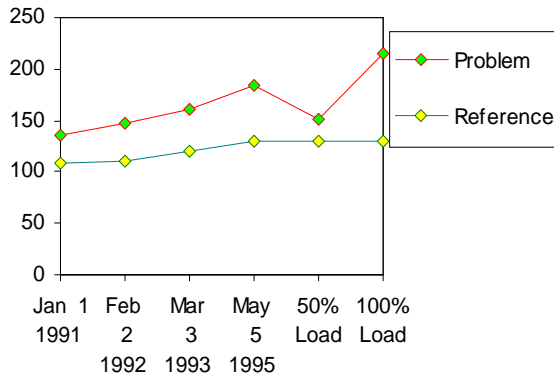
Thermal Information	
Repair Priority:	2-Serious
Component Temperature On A Phase:	185 F
C Phase Reference Temperature:	130 F
Temperature Rise Above Reference:	55 F

RATED LOAD:	50	amps
A Phase:	40	amps
C Phase:	40	amps
		amps

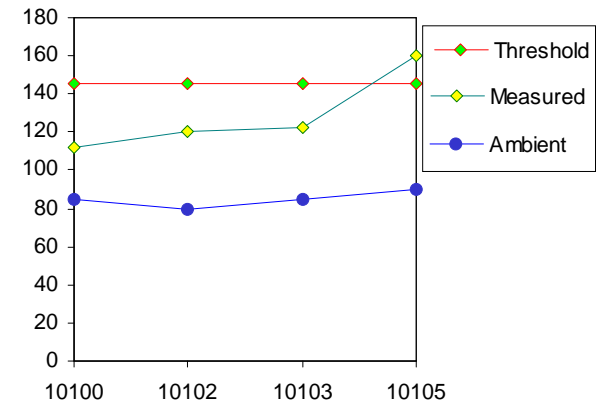
DC_060903_005.jpg

Inspection No	Date Inspected	Test Status	Measured Temp	Threshold Temp	Ambient Temp	Status Note	Customer Notes
10100	1/1/1991	TESTED	112 F	145 F	85 F	Motor was tested at full running load after it had been running for 3 hours.	Motor was at full running load
10102	2/2/1992	TESTED	120 F	145 F	80 F		The motor was running for 1 hour
10103	3/3/1993	TESTED	122 F	145 F	85 F		motor was running for 2 hours
10105	5/5/1995	TESTED	160 F	145 F	90 F	Test was done after 3 hours	The motor is over its Alarm Threshold temp by 15 deg.
